**Archaeological investigation at
Caludon Castle,
Farren Road, Coventry**

Report 0332
August 2003

Warwickshire Museum Field Services
The Butts
Warwick
CV34 4SS

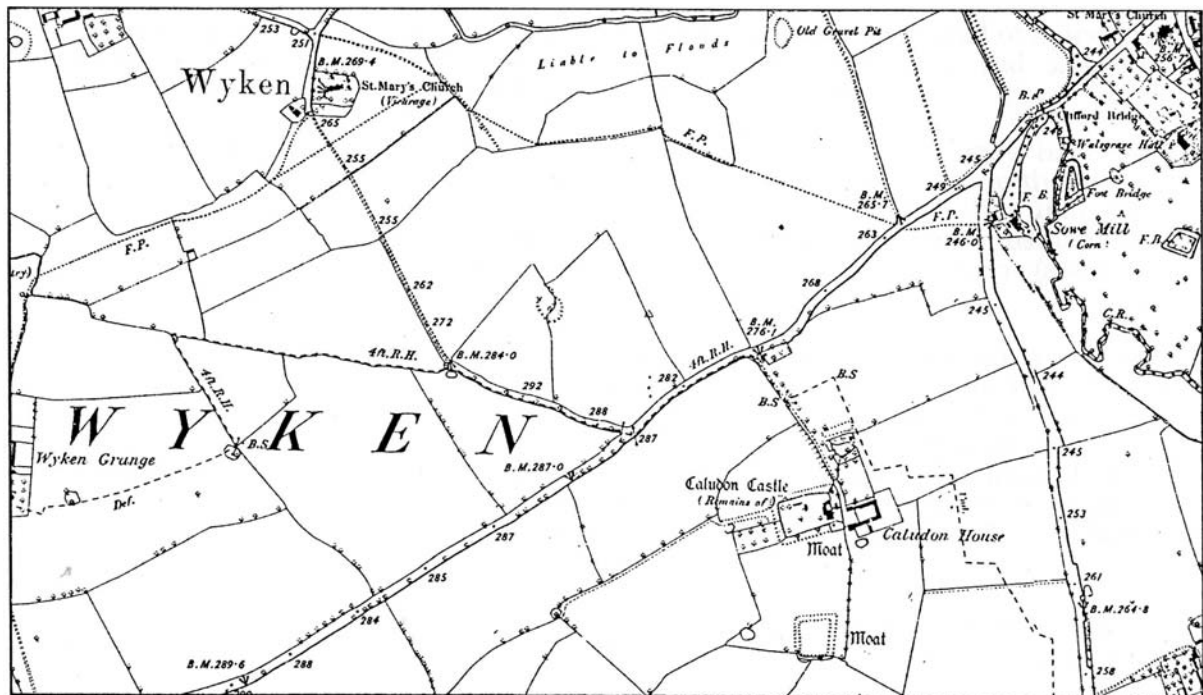
Fig. 2 Detail from 1st edition Ordnance Survey 1:10560 map of 1887

4.5 North of the moat was a mere, which may have provided water for a mill, held back by an earthen bank at the eastern end which also served as a causeway for the access route to the castle from Farren Road,. On the eastern side of the dam was a fishpond or possibly fishponds probably fed via a channel from the mere and then drained eastwards to the River Sowe. The mill may have been located at the southern end of the causeway. The positions of the mere, fishponds and possible channel are shown on the 1887 to 1948 Ordnance Survey maps (Ordnance Survey 1887, 1938, Figs. 2 and 3, and 1948).

4.4 The castle was bought by Thomas Morgan in 1631, but it may have been damaged at the end of the English Civil War during a similar period to the walls of Coventry having been largely destroyed by order of King Charles II in 1662 (VCH 1969, 23). The remainder of the castle fell into disrepair and was partly dismantled to provide stone for local buildings, including Caludon House and farm (shown on Figs. 2 and 3).

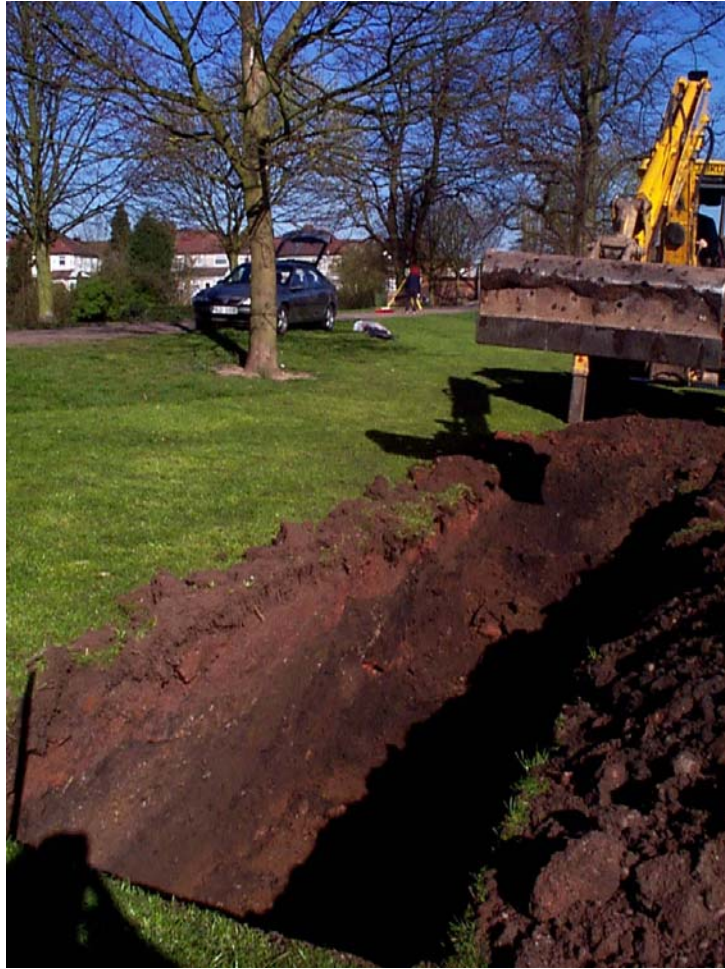
Fig. 4: Machining of Trench 1

5.1 The two evaluation trenches were positioned close to the base of the slope of the existing embankment, but not at the bottom of slope. They were opened by a JCB-type machine opened the trenches timber off-cuts being used to level the machine and reduce the risk of sinkage into soft ground.

5.2 The trenches measured 1.6m wide and were excavated using a toothless ditching bucket under archaeological supervision. The trenches were initially 38-39m long, but both were extended by 34m following the initial findings and the result of a project review meeting.

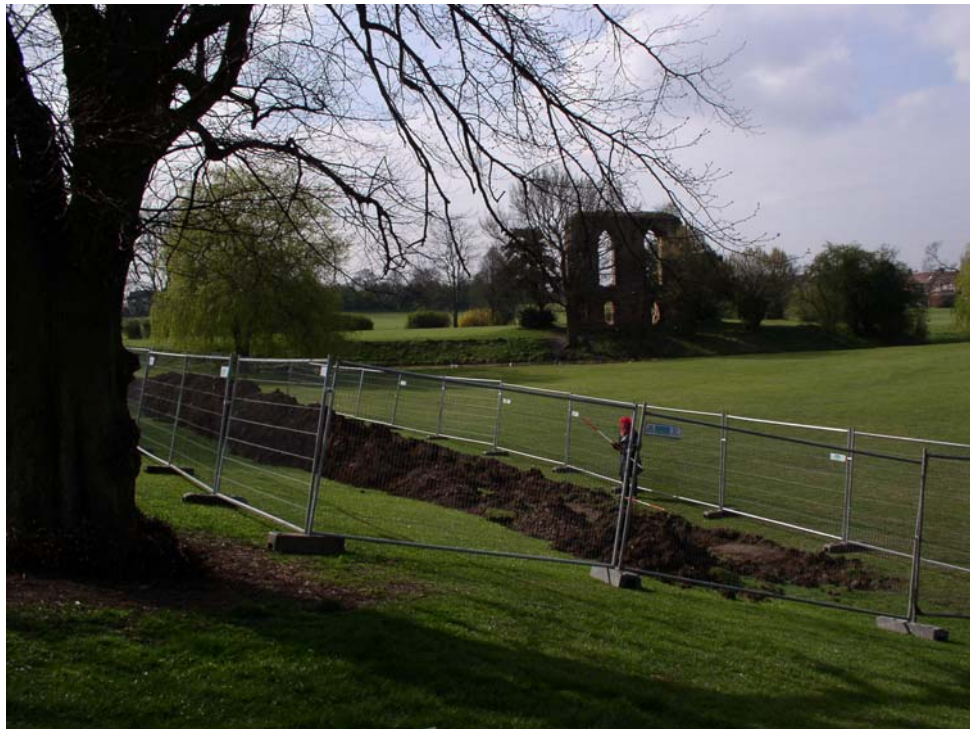
Fig. 5: Trench 2 and Caludon Castle

5.9 The 62m long trench was situated on the western side of the embankment with the southern end 4m away from the moat and the Scheduled Area of the castle. The deposits revealed in the trench were broadly similar to those in Trench 1. The original 39m long trench was extended northwards following the result of a liaison meeting. The extended trench was positioned away from the likely extent of major root systems of established trees on the embankment and in relation to a previously excavated sump.
